Test Report No. 456495

| Test assignment: | Testing of Spinmax J65-32 and accessories |

Empa, Swiss Federal Laboratories for Materials Science and Technology
Laboratory for Structural Engineering
Dübendorf, March 24, 2011

This test report describes tensile and torsion tests and its test results for Spinmax J65-32 (D=32 mm, EP resin) and related accessories.

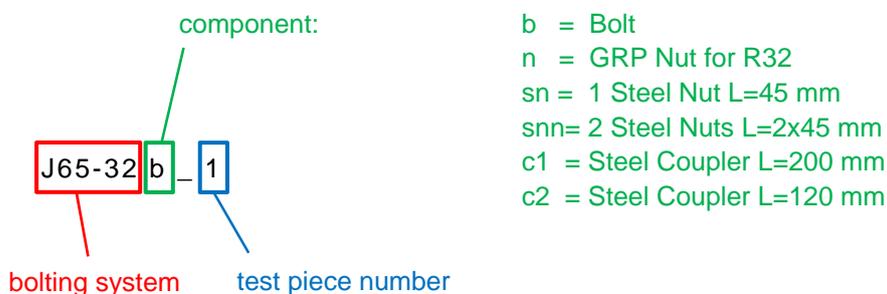
Using the following example the explanation is given on how the test piece name is built up:

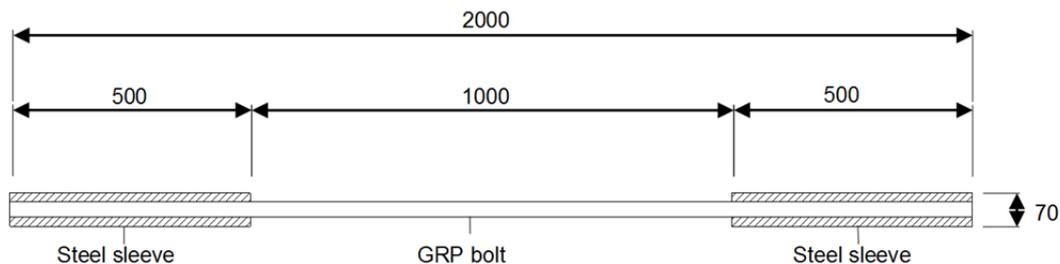
Figure 1 shows the test piece geometry. The free GRP bolt length was 1000 mm. Both ends of the 2000 mm long GRP bolt were glued into steel sleeves in the factory.

Figure 1: Test piece for the bolt tensile tests [mm].

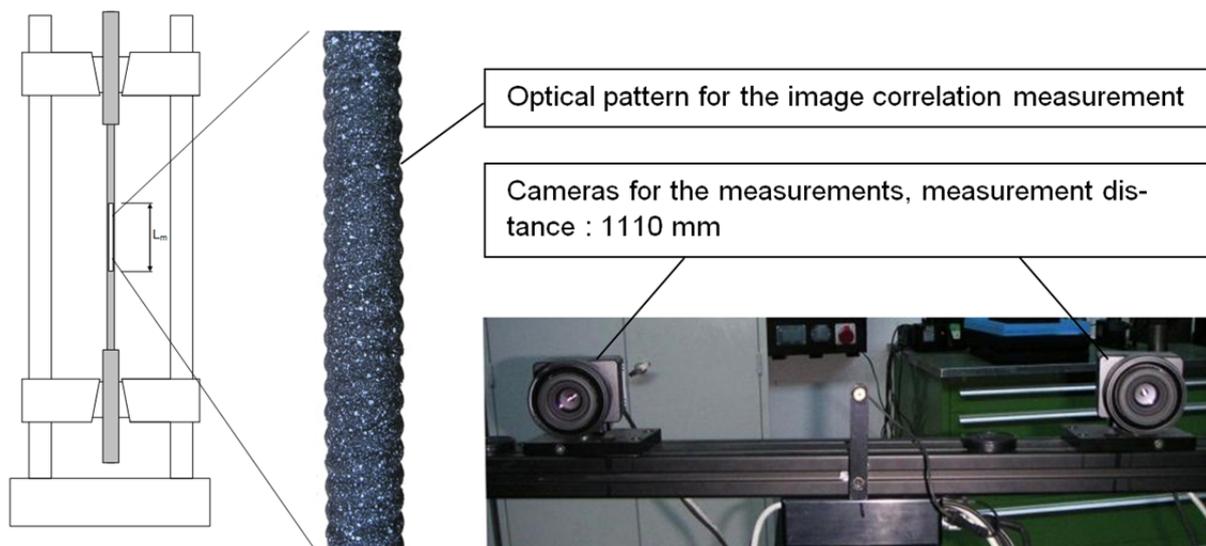
The test set up is shown in Figure 2. The cross head displacement and the force were measured. The measurement of the cross head displacement is subsequently designated as 'test machine displacement reading'. The strain was measured contactless with an image correlation system within a field with a length of $L_m = 300$ mm. The image correlation system took pictures with a frequency of 0.4 Hz. The software calculated the surface profile and the displacements in three orthogonal directions. The accuracy of the measured displacements was ± 0.005 mm. The strain was calculated using the relative displacement between two selected points along the bolt axis.

Figure 2: Test set up for the bolt tensile tests with image correlation system.

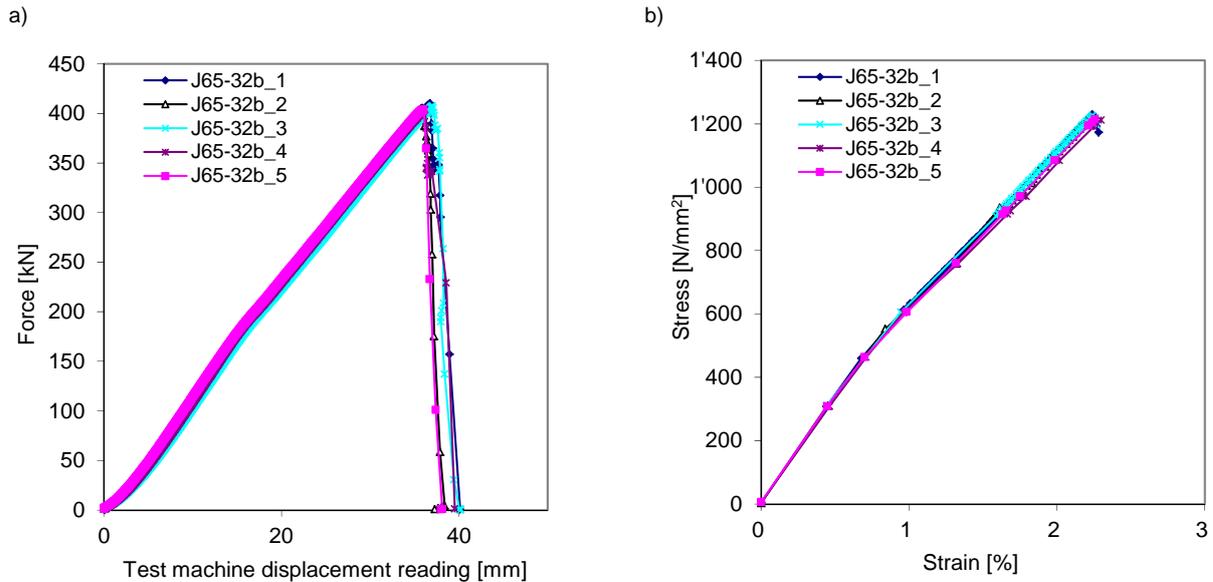
Figure 3a) shows the force-displacement relationships and Figure 3b) the stress – strain relationships of the bolts. The stress – strain relations have a linear and coincident course.

Figure 3: Relationships for a) force – machine displacement reading, b) stress – strain (from the image correlation system).

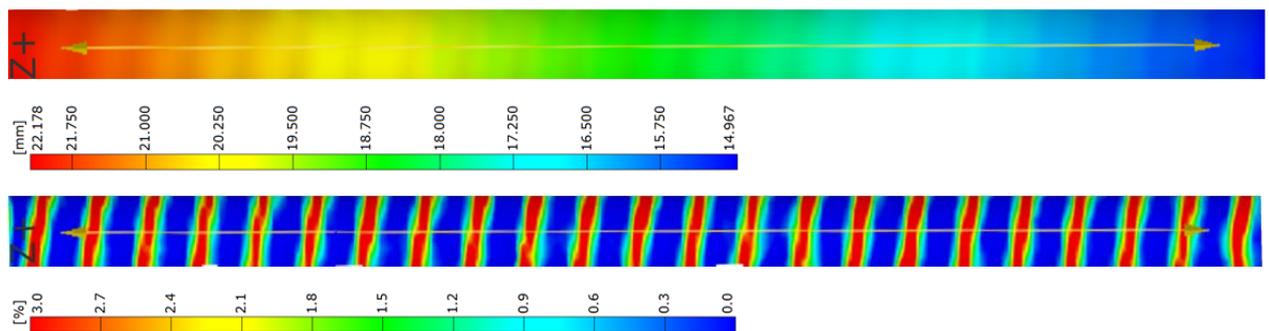
Figure 4 shows examples of the displacement and strain fields close to maximum force for J65-32b_1.

Figure 4: Displacement and strain fields of the image correlation measurement for J65-32b_1 close to maximum force. The arrow line represents the distance for the strain measurements.

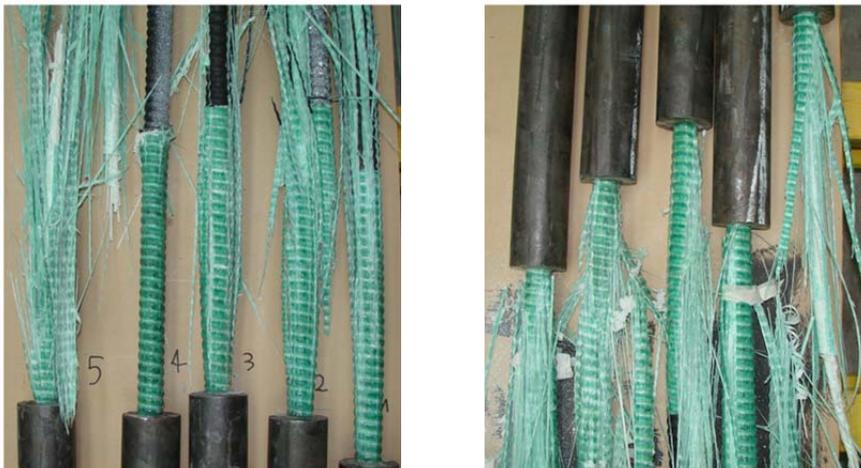
Figure 5 shows the bolts after the tests.

Figure 5: Photograph of failure patterns. The black color was applied for the image correlation measurements.

Failure occurred in a brittle manner with a sequence of loud banging noises. The bolts were partially separated. The bolts experienced a fibrous fracture pattern (Figure 5).

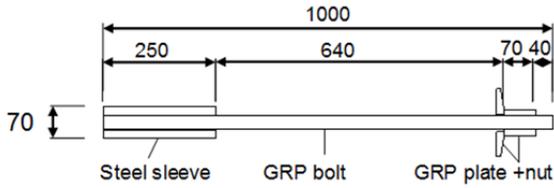
Figures 6 and 7 show the geometry of the test pieces for the tests with the nuts. One end of the test piece was glued into a steel sleeve in the factory and the other end was equipped with either (1) a GRP nut plus

a GRP plate (Figure 6) or (2) one or two Steel Nuts (Figure 7). The free end of the bolt had a length of 40 mm. In the case where 2 Steel Nuts have been applied, the nuts have been tightened together by hand before testing.

Figure 6: Test piece for the tests with GRP Nuts [mm].

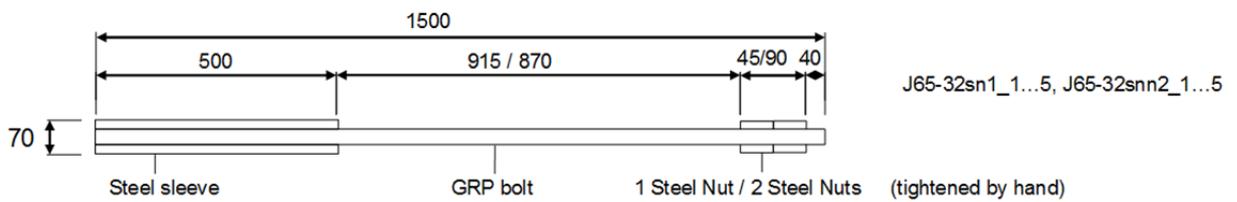
Figure 7: Test piece for the tests with steel nuts [mm].

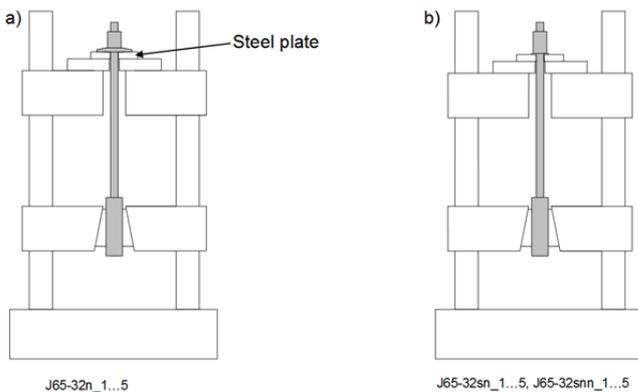
Figure 8 shows the test set up. To prevent eccentric loads from acting on the test pieces a steel plate with a hole diameter of 34 mm was placed underneath the nuts. This plate was protected by a washer in the case where steel nuts were tested. The steel sleeve at the other end was clamped.

Figure 8: Test set up for the tensile tests a) with GRP nuts plus GRP – plates, b) with steel nuts.

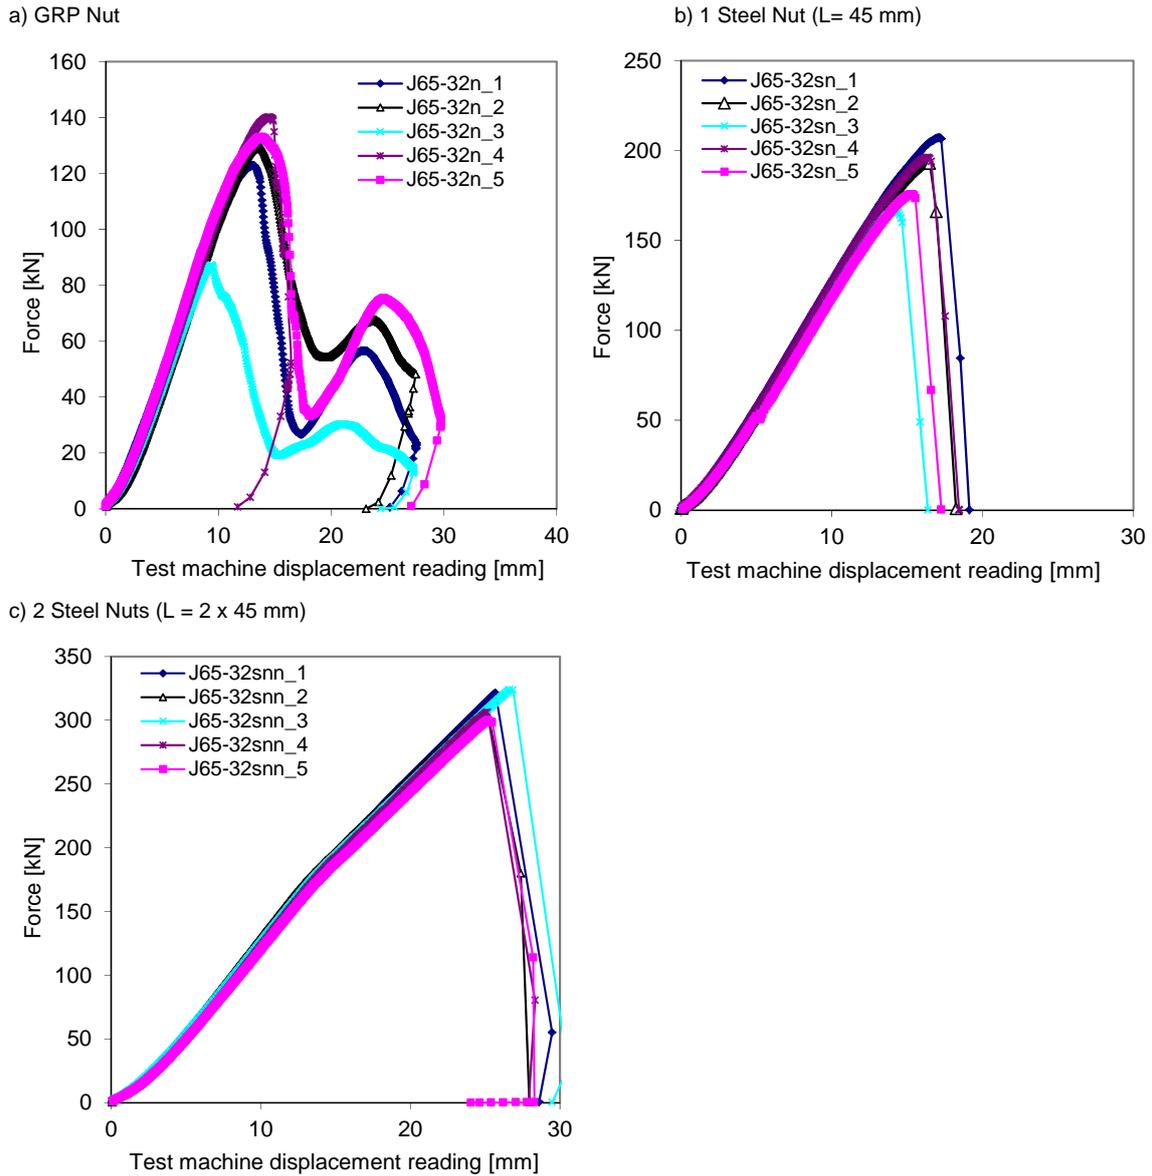
Figure 9 shows the force – test machine displacement relationships for the tests with nuts.

Figure 9: Force – displacement relation for the nuts.

With the GRP Nut, a softening behavior could be observed (Figure 9a). The free bolt length above the nut was distinctly smaller than the initial 4 cm, except with test piece 4 (Figure 10), but there the nut was crushed.

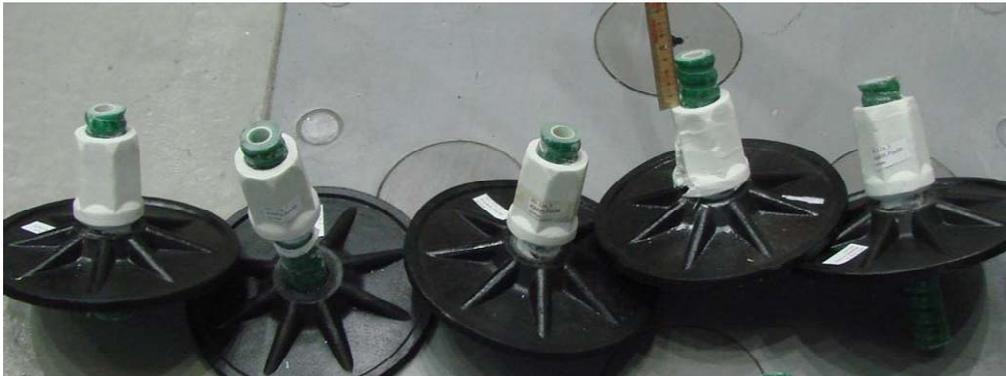
The maximum forces of the GRP Nuts are listed in Table 3. Figure 10 shows the anchorage heads after the tests.

Figure 10: GRP Nuts and plates after the test. Since the nuts could not be loosened, the bolts were cut after the tests.

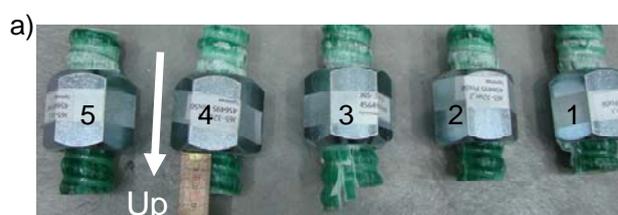
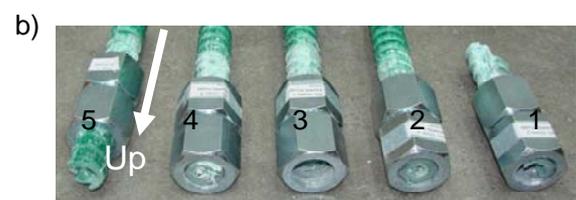
The maximum forces for the Steel Nuts are listed in Tables 4a) and b). The Figures 11a) und b) show the anchorage heads after the tests.

Figure 11: Steel Nuts after the tests. a) L = 1 x 45 mm and b) L = 2 x 45 mm. Since the nuts could not be loosened, the bolts were cut after the tests.

The test pieces failed in a brittle manner accompanied by a banging noise. The bolts were pulled out the nuts (Figure 11a und b).

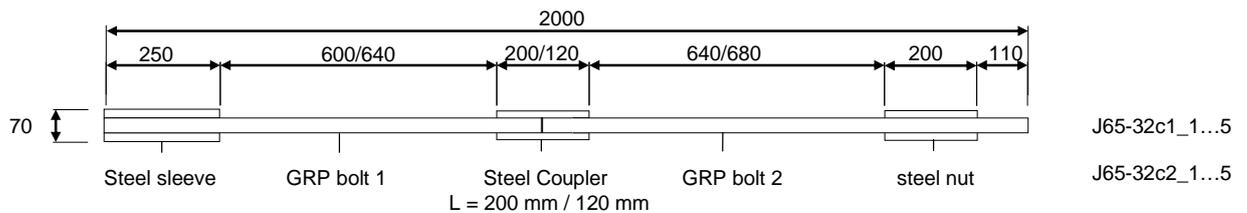
Figure 12 shows the geometry of the test pieces with couplers. One end was equipped with an over-the-bolt glued steel sleeve and the other end with a steel nut. The free end of the GRP bolt 2 had a length of 110 mm. The two GRP bolts (bolt 1 and bolt 2) were joined with the Steel Coupler, which was centrally attached to both bolt ends with the ends touching each other. Two different lengths have been chosen for the couplers (L = 200 and L = 120 mm).

Figure 12: Test piece for the coupler tests [mm].

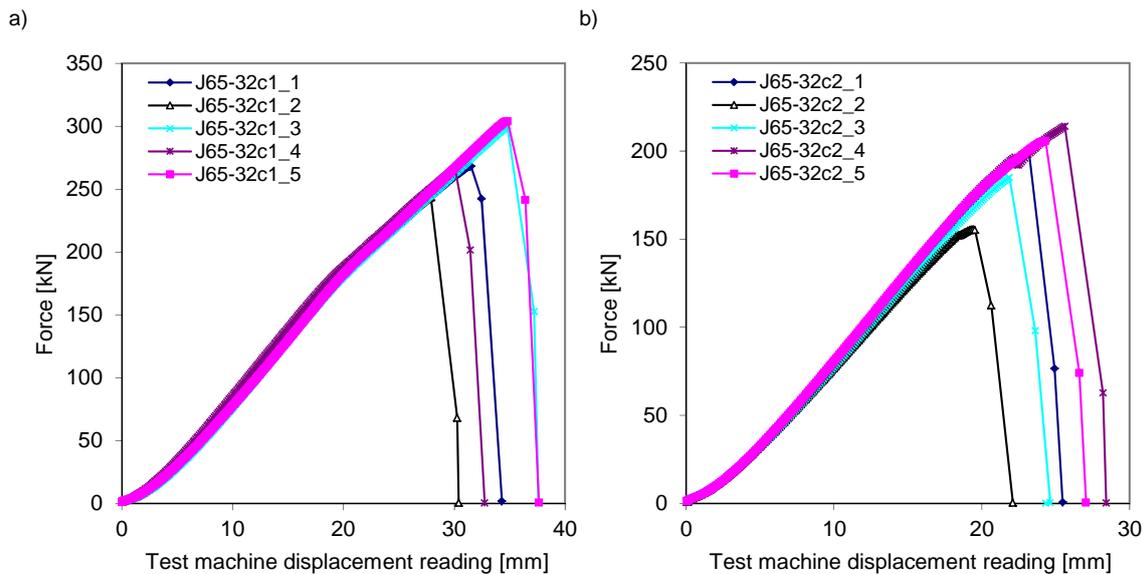
Figure 14 shows the force – displacement relationships for the tests with the Steel Couplers.

Figure 14: Force – displacement relationships for the tests with couplers. a) L=200 mm and b) L=120 mm.

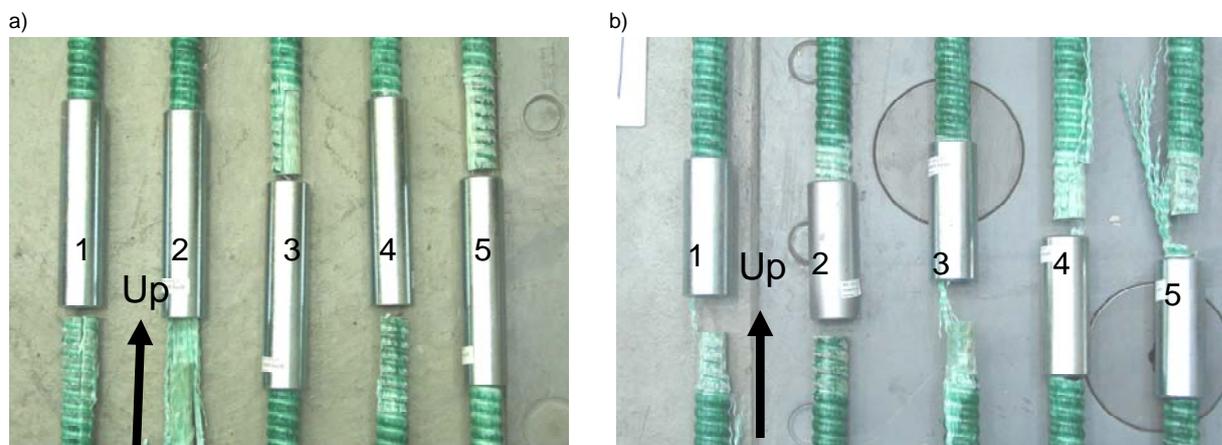
Figure 15 shows the Steel Couplers after the tests.

Figure 15: Steel Couplers, a) L = 200 mm and b) L = 120 mm with pulled out bolts.

The test pieces failed in a brittle manner accompanied by a banging noise. The bolts were pulled out of the couplers (Figure 15).

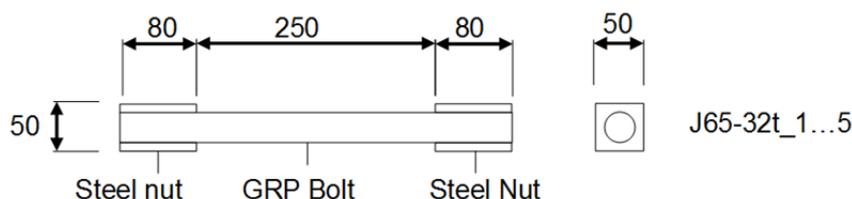
Figure 12 shows the geometry of the test pieces. The free GRP length was 250 mm. Both ends of the 410 mm long GRP bolt were glued into steel nuts 50x50mm in the factory.

Figure 16: Test pieces for the torsion tests [mm].

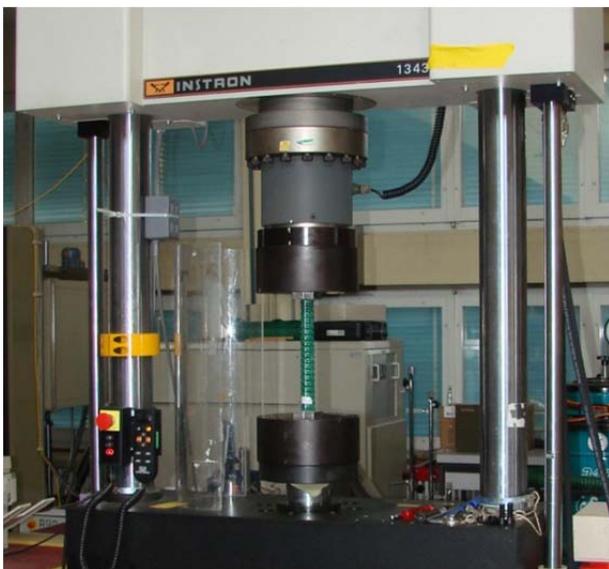
The test piece was clamped with its both nuts in the 2000 Nm test machine (Figure 17). The rotation angle and the torsion moment were measured. The measurement uncertainty for the torsion moment was smaller than 1% of the load over the 2'000 Nm measuring domain.

Figure 17: Torsion test machine with clamped test piece prior to the test.

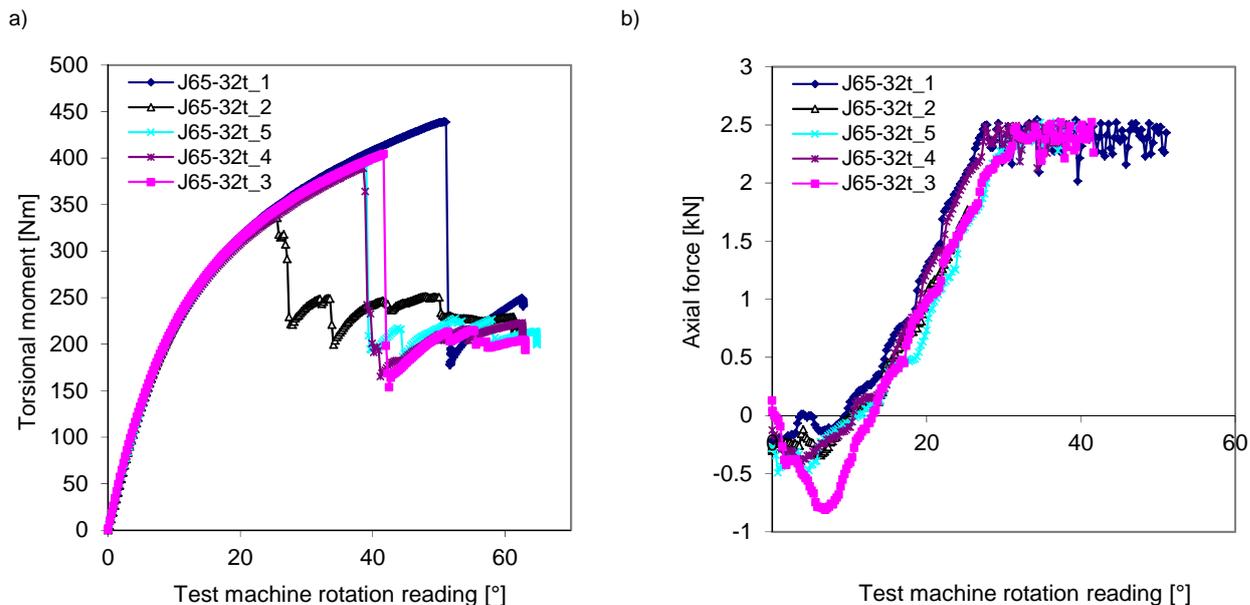
Figure 18a shows the torsion moment rotation angle relation of the Bolts. Since the length of the bolts decreased, an axial force appeared, due to the stiffness of the testing machine (Figure 18b). In order to minimise the axial force, the control system was programmed to correct the position of the clamping as soon as the threshold value of 2.5 kN, which was the minimum possible value, was exceeded.

Figure 18: Relationships a) torsion moment – test machine rotation reading, b) normal force – test machine rotation reading for the control of the to 2.5 kN limited tensile force.

The torsion moment – test machine rotation reading (Figure 18a) shows an abrupt drop of the force after the breaking torsion moment. The failure was accompanied by a short clicking noise. The bolts weren't considerably damaged (Figure 19). Only a remaining relative rotation between the nuts with an uniform rotation distribution along the Bolt and some visible cracks along the whole bolt length appeared.

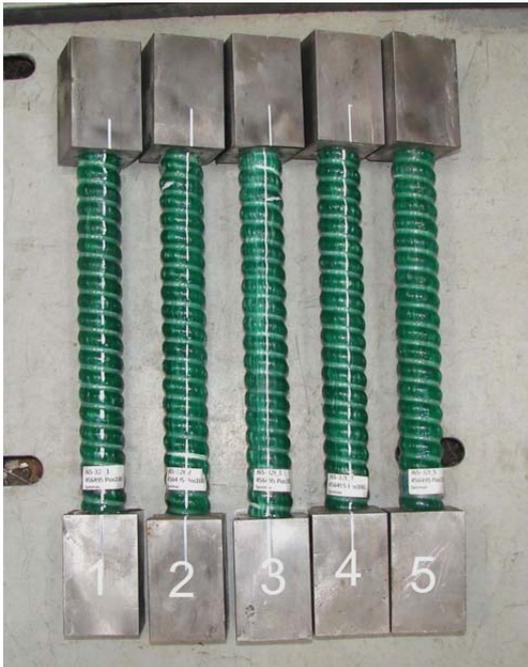
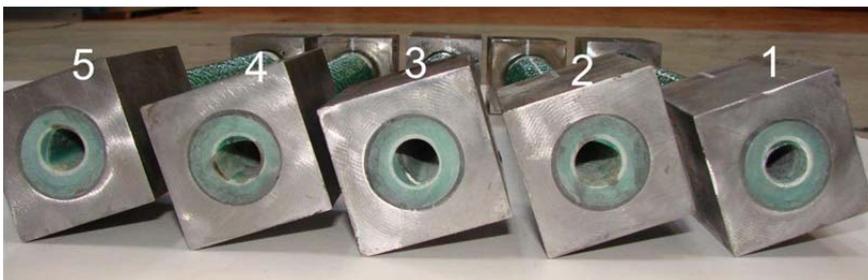
Figure 19 shows the test pieces after the tests. The white lines have been painted prior to the tests as straight lines parallel to the bolt axis, in order to control the bolt rotation distribution.

Figure 19: Test pieces after the torsion tests with remaining relative rotation.

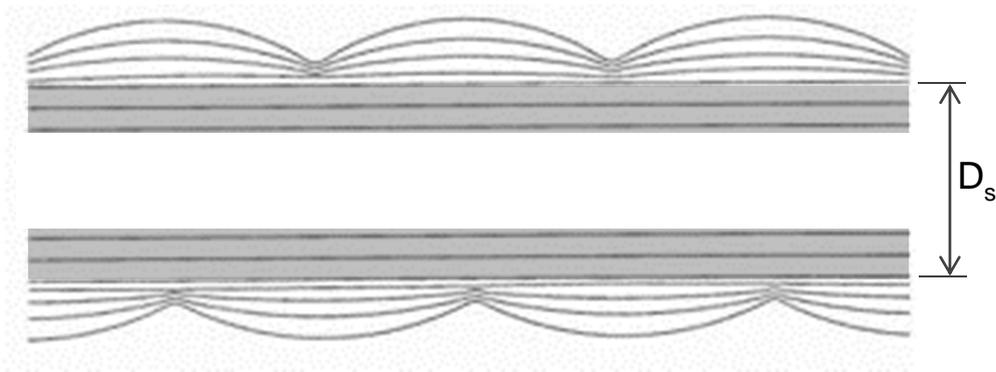
Figure 20 schematically shows a longitudinal section of the GRP bolt. The cross section of the anisotropic GRP bolt is composed of a portion of unidirectional fibers within the core cross section, plus a portion of undulated fibers in the outer layer.

The stress section A_s is related to the core cross section with unidirectional fibers.

The stress section in the figure lies within the grey highlighted area of the height D_s .

D_s : Relevant diameter for the determination of the stress section A_s

Figure 20: Schematic longitudinal section of a GRP Bolt.

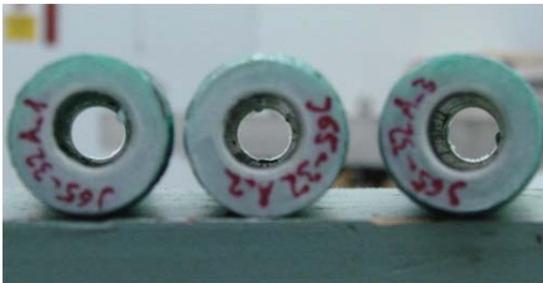
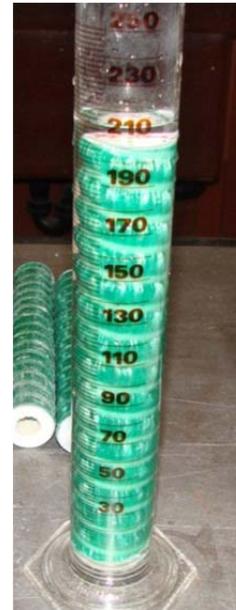
3 bolt test pieces (J65-32A_1, J65-32A_2 und J65-32A_3) were trimmed to the length of about 200 mm for the determination of the mean cross sectional area. Subsequently, the lengths were exactly measured and the volume of water displaced was measured using a 250 ml measuring cup (Figure 21). No air bubbles were observed at the test piece surface.

Figure 21: Test pieces with hollow section and measuring cup.

The cross sectional area was calculated by dividing the displaced volume of water by the test piece length. Table 8 shows the measured water volumes and the calculated cross sectional areas.
